### Inspection photos

# Inspection report

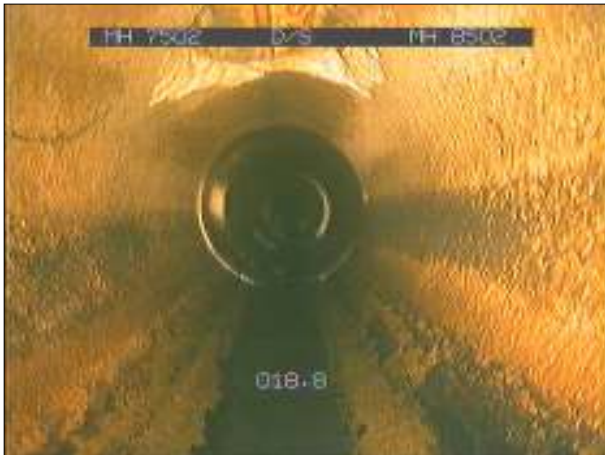
Photo: 4\_12a, 00:02:11  
18.8m, Hole in sewer at 12 o'clock

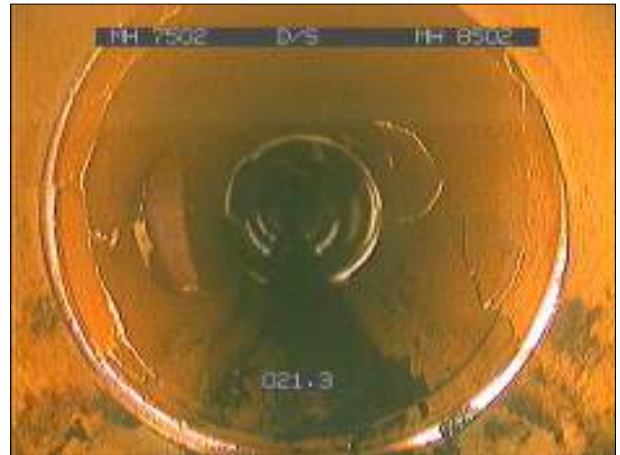
Photo: 4\_14a, 00:02:38  
21.3m, Multiple Fractures from 12 to 12 o'clock

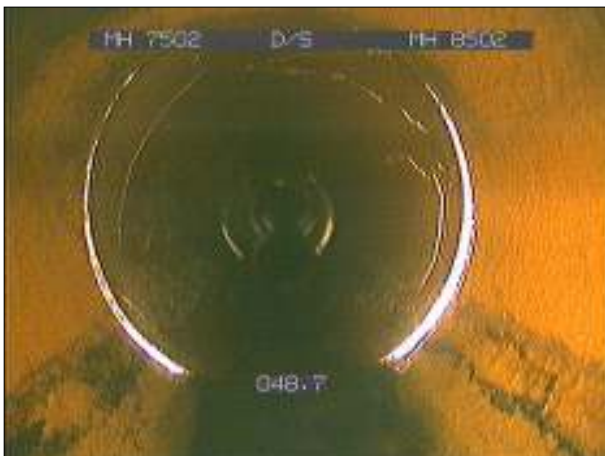
Photo: 4\_30a, 00:06:09  
48.7m, Multiple Fractures from 12 to 12 o'clock

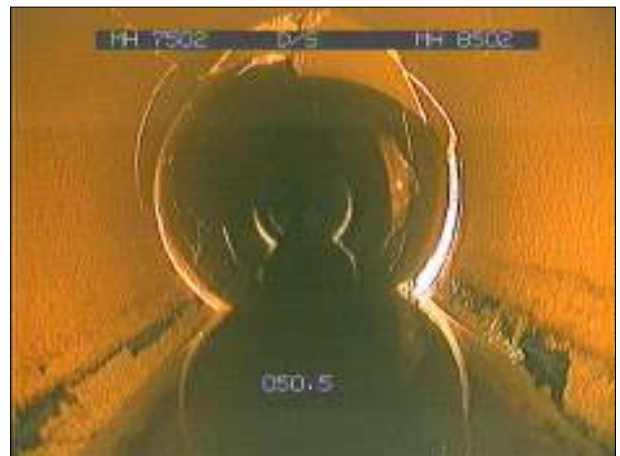
Photo: 4\_35a, 00:06:35  
50.5m, Sewer Broken, at 12 o'clock

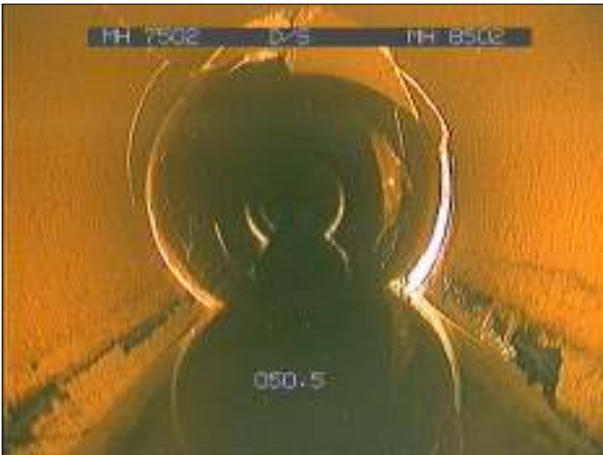
Photo: 4\_36a, 00:06:40  
50.5m, Circumferential Fracture, from 09 to 11 o'clock

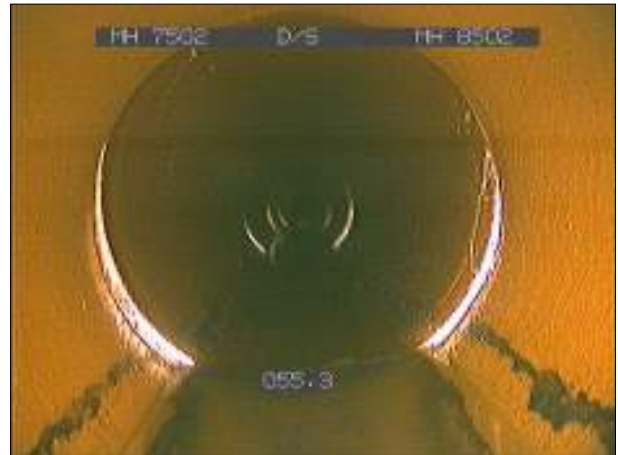
Photo: 4\_41a, 00:07:26  
55.3m, Circumferential Fracture at joint, from 03 to 05 o'clock

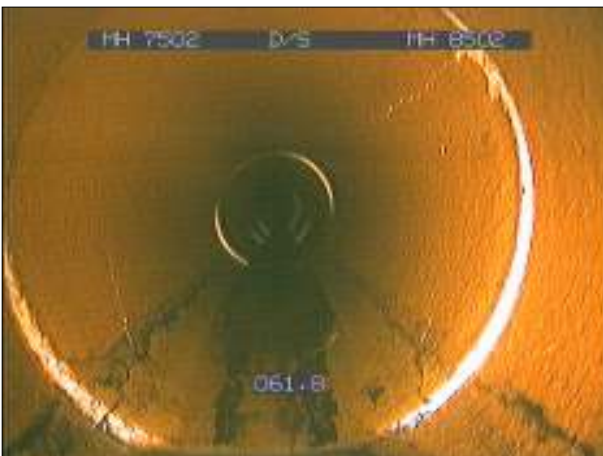
Photo: 4\_45a, 00:08:39  
61.8m, Longitudinal Fracture at joint at 07 o'clock

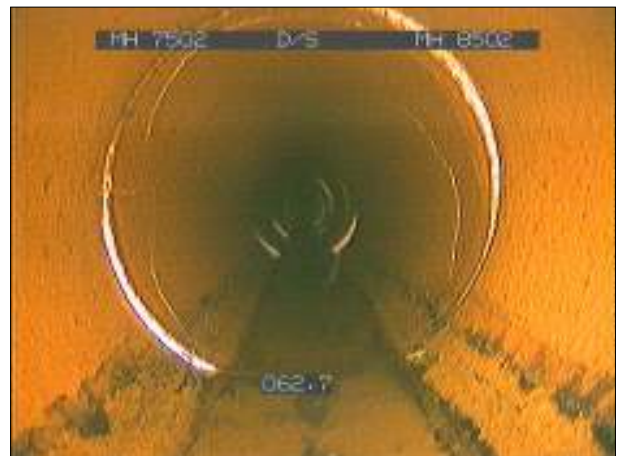
Photo: 4\_47a, 00:08:54  
62.7m, Circumferential Crack at joint, from 12 to 12 o'clock

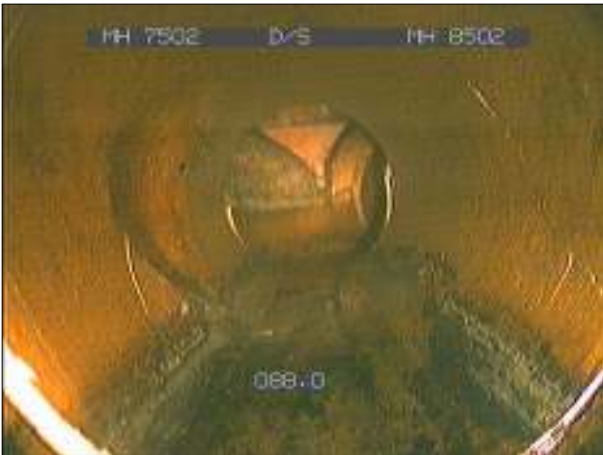
Photo: 4\_60a, 00:11:57

88m, Circumferential Fracture at joint, from 07 to 09 o'clock

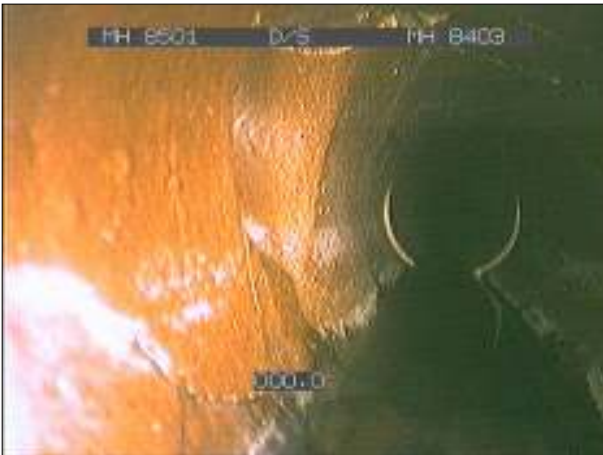
Photo: 112\_4a, 00:00:17  
0m, Circumferential Fracture, from 07 to 02 o'clock

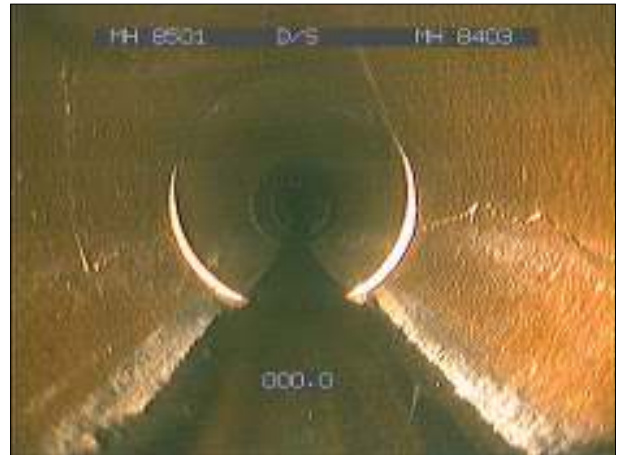
Photo: 114\_6a, 00:00:30  
0m, Longitudinal Fracture at 03 o'clock

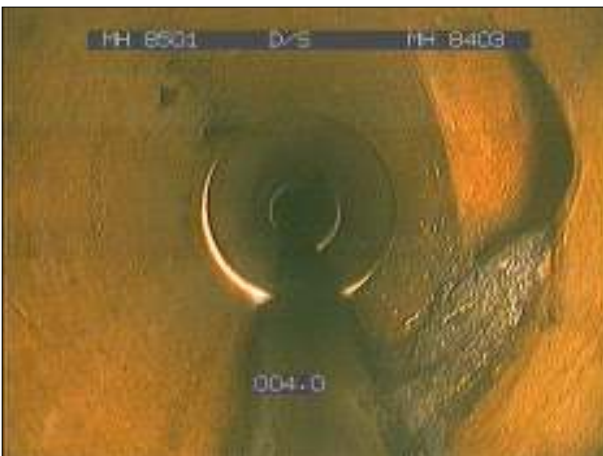
Photo: 5\_10a, 00:01:04  
4m, Encrustation light, from 03 to 05 o'clock, Remark: FROM JN

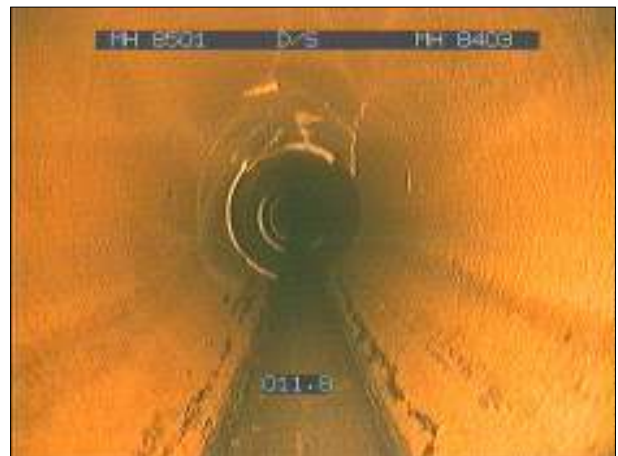
Photo: 5\_17a, 00:02:15  
11.8m, Multiple Cracks, from 08 to 04 o'clock

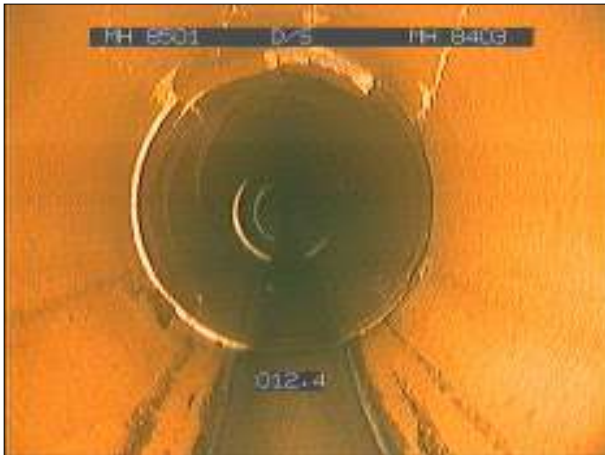
Photo: 5\_18a, 00:02:49  
12.4m, Hole in sewer at 12 o'clock

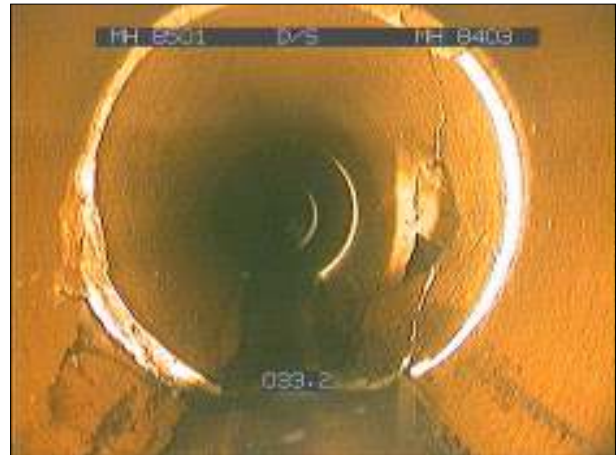
Photo: 139\_30a, 00:05:47  
33.2m, Circumferential Fracture at joint, from 01 to 05 o'clock

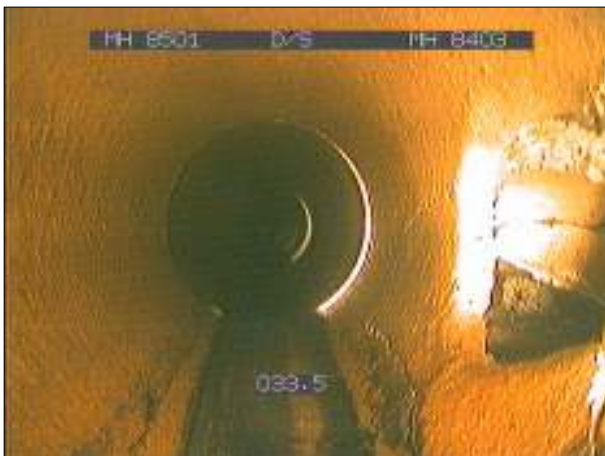
1:124	position	code	observation	MPEG	photo	grade
	17.30	CLJ	Longitudinal Crack at joint, at 12 o'clock	00:03:35		(Struct) 2
	20.40	JN	Junction at 03 o'clock, dia 100 mm	00:04:03		(Constr) 0
	23.50	CCJ	Circumferential Crack at joint, from 09 to 01 o'clock	00:04:23		(Struct) 2
	25.60	CC	Circumferential Crack, from 06 to 08 o'clock	00:04:38		(Struct) 2
	26.50	JN	Junction at 09 o'clock, dia 100 mm	00:04:49		(Constr) 0
	28.80	CCJ	Circumferential Crack at joint, from 07 to 05 o'clock	00:05:16		(Struct) 2
	30.00	JN	Junction at 03 o'clock, dia 100 mm	00:05:26		(Constr) 0
	33.20	FCJ	Circumferential Fracture at joint, from 01 to 05 o'clock	00:05:47	139_30a	(Struct) 3
	33.50	CX	Connection defective, at 03 o'clock, dia 100 mm, Remark: INVERT MISSING IN CN	00:06:03	140_31a	(Constr) 4
	40.50	JN	Junction at 10 o'clock, dia 100 mm	00:06:51		(Constr) 0

Photo: 140\_31a, 00:06:03  
33.5m, Connection defective, at 03 o'clock, dia 100 mm,  
Remark: INVERT MISSING IN CN

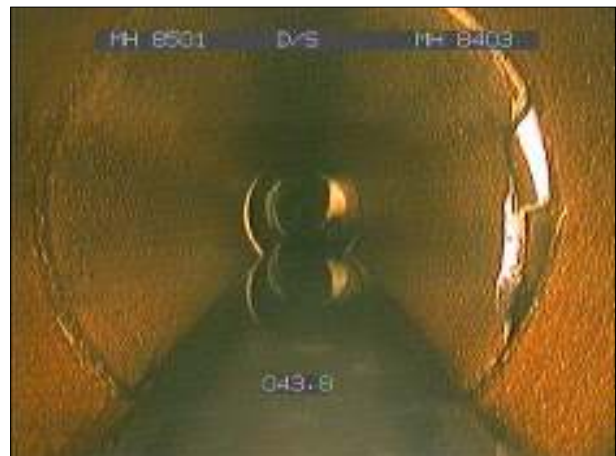
1:124	position	code	observation	MPEG	photo	grade
	42.90	FCJ	Circumferential Fracture at joint, from 12 to 04 o'clock	00:07:05		(Struct) 3
	43.00	JN	Junction at 03 o'clock, dia 100 mm	00:07:10		(Constr) 0
	43.80	H	Hole in sewer at 03 o'clock	00:07:19	144_35a	(Struct) 4
	45.30	CNI	Connection, at 03 o'clock, dia 100 mm, intrusion 40 mm	00:07:32	145_36a	(Constr) 4
	45.30	CN	Connection, at 09 o'clock, dia 100 mm	00:07:44		(Constr) 0
	45.60	SA	Survey abandoned, Remark: DUE TO INTRUDER	00:08:26		(Misc) 0

Photo: 144\_35a, 00:07:19  
43.8m, Hole in sewer at 03 o'clock

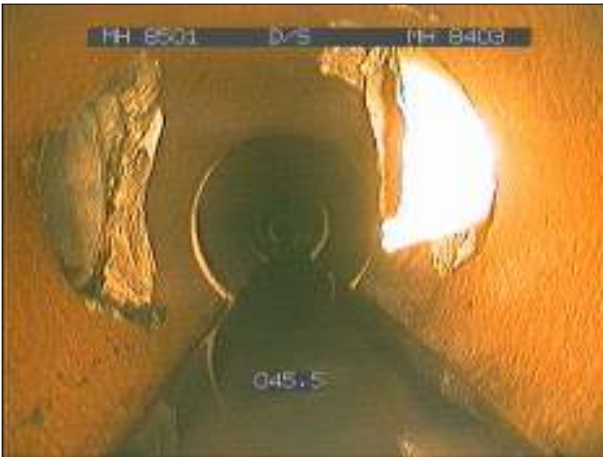
Photo: 145\_36a, 00:07:32  
45.3m, Connection, at 03 o'clock, dia 100 mm, intrusion 40 mm

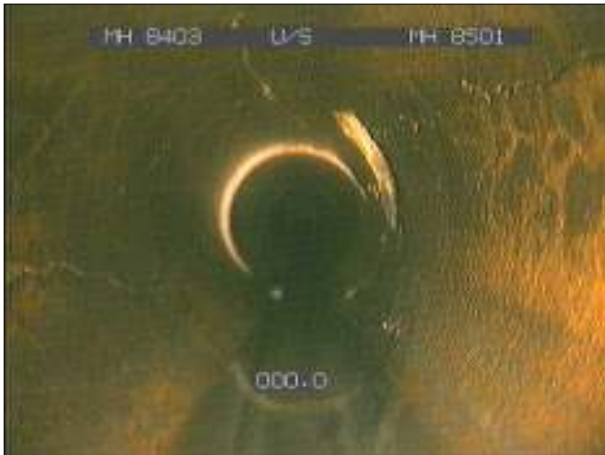
0.00	FL	Longitudinal Fracture at 09 o'clock	00:00:00	151_4a	(Struct) 3
	0.00	FL	Longitudinal Fracture at 12 o'clock	00:00:00	152_5a	(Struct) 3
	0.00	FL	Longitudinal Fracture at 02 o'clock	00:00:00	153_6a	(Struct) 3

Photo: 151\_4a, 00:00:00  
0m, Longitudinal Fracture at 09 o'clock

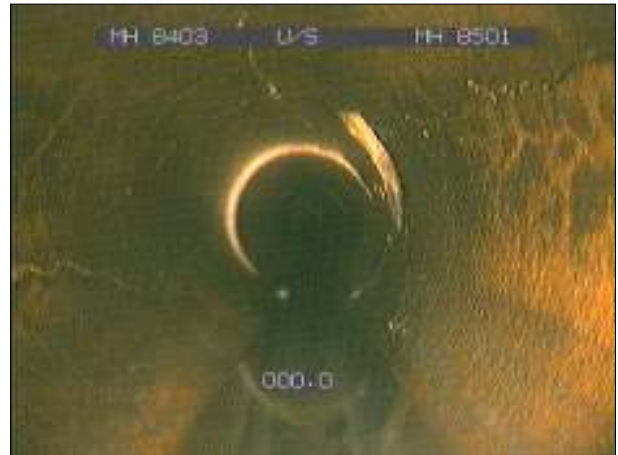
Photo: 152\_5a, 00:00:00  
0m, Longitudinal Fracture at 12 o'clock

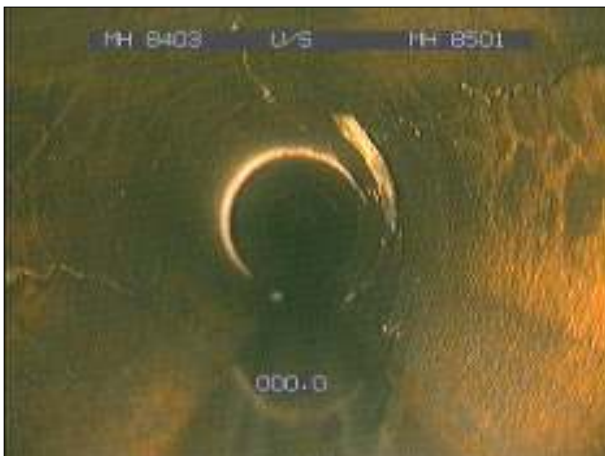
Photo: 153\_6a, 00:00:00  
0m, Longitudinal Fracture at 02 o'clock

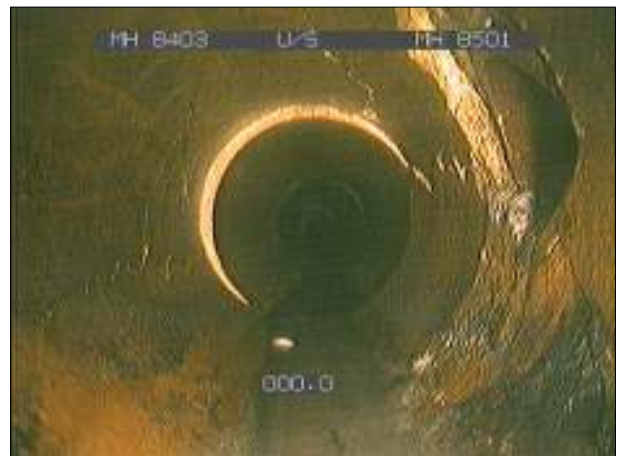
0.00	FCJ	Circumferential Fracture at joint, from 03 to 05 o'clock	00:00:19	154_7a	(Struct) 3
	0.00	CN	Connection, at 02 o'clock, dia 100 mm	00:00:29		(Constr) 0

Photo: 154\_7a, 00:00:19  
0m, Circumferential Fracture at joint, from 03 to 05 o'clock

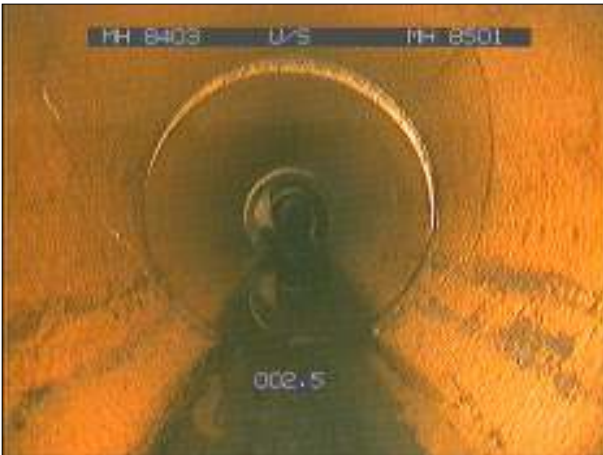
0.00	B	Sewer Broken, at 02 o'clock	00:00:34		(Struct) 4
	0.60	JN	Junction at 09 o'clock, dia 100 mm	00:00:43		(Constr) 0
	2.50	FC	Circumferential Fracture, from 01 to 10 o'clock	00:00:56	158_11a	(Struct) 3

Photo: 158\_11a, 00:00:56  
2.5m, Circumferential Fracture, from 01 to 10 o'clock

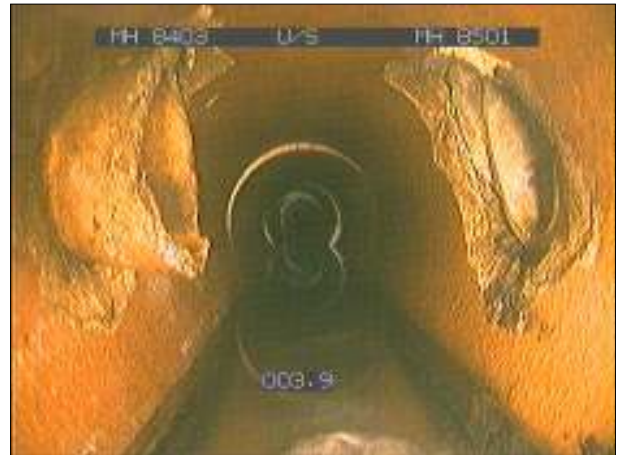
3.90	CNI	Connection, at 09 o'clock, dia 100 mm, intrusion 40 mm	00:01:21	159_12a	(Constr) 4
	3.90	CN	Connection, at 03 o'clock, dia 100 mm	00:01:24		(Constr) 0

Photo: 159\_12a, 00:01:21  
3.9m, Connection, at 09 o'clock, dia 100 mm, intrusion 40 mm

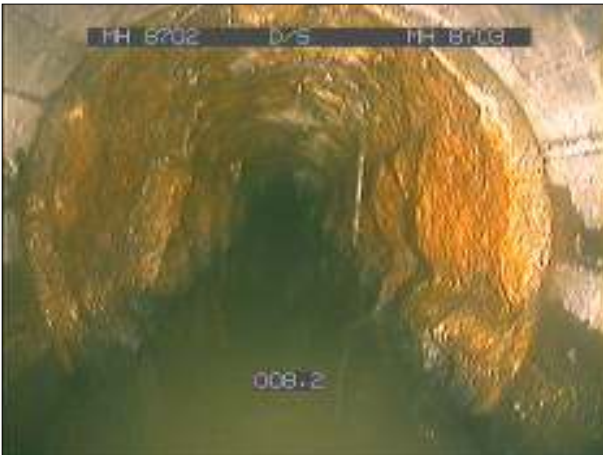
Photo: 247\_5a, 00:00:48  
8.2m, Sewer Material changes at this point, Cast iron

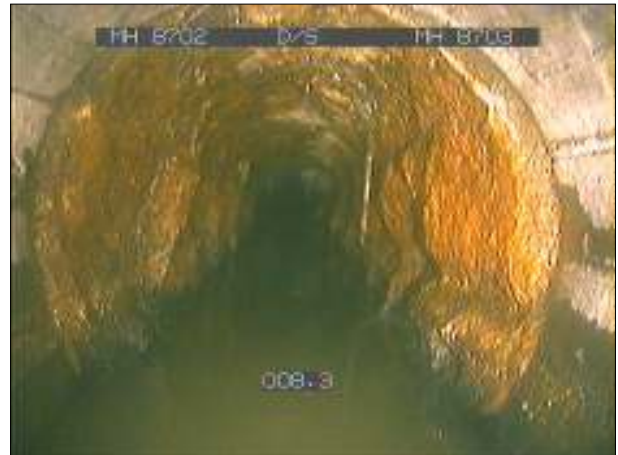
Photo: 248\_6a, 00:00:53  
8.2m, Encrustation heavy, from 07 to 05 o'clock, 25% cross-sectional area loss

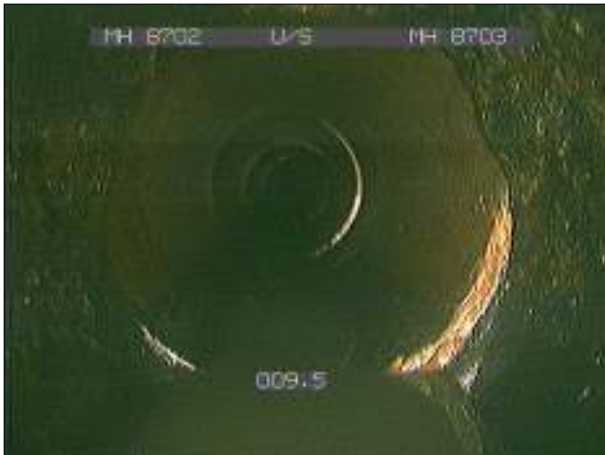
Photo: 267\_9a, 00:01:34  
9.5m, Joint displaced. Medium

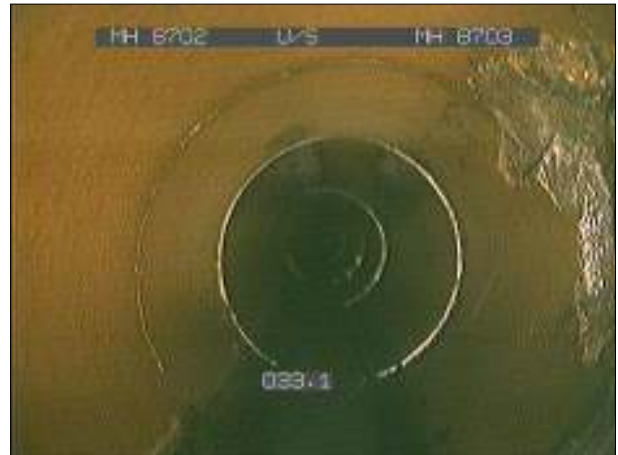
Photo: 274\_16a, 00:03:28  
33.1m, Circumferential Fracture, from 07 to 01 o'clock

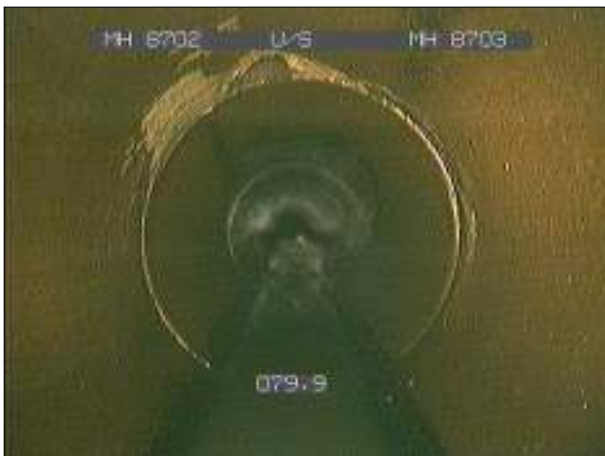
Photo: 283\_25a, 00:06:54  
79.9m, Hole in sewer at 12 o'clock, Remark: AT JOINT

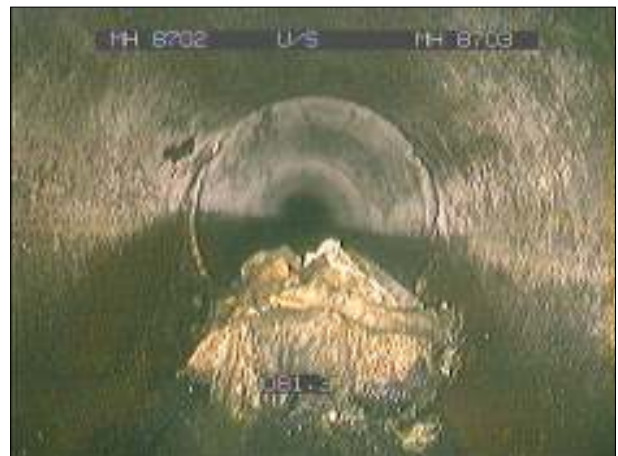
Photo: 284\_26a, 00:07:08  
81.3m, Obstruction, 50 % height/diameter loss, Remark: SCALE, RAG AND FAT LUMP
